December 6, 2024

RE: *Pointe Towers Condominium, Inc.*  
*555 Gulf Way*  
*St. Pete Beach, Florida 33706*  
*KEG File #24RP-0079: Structural Integrity Reserve Study*

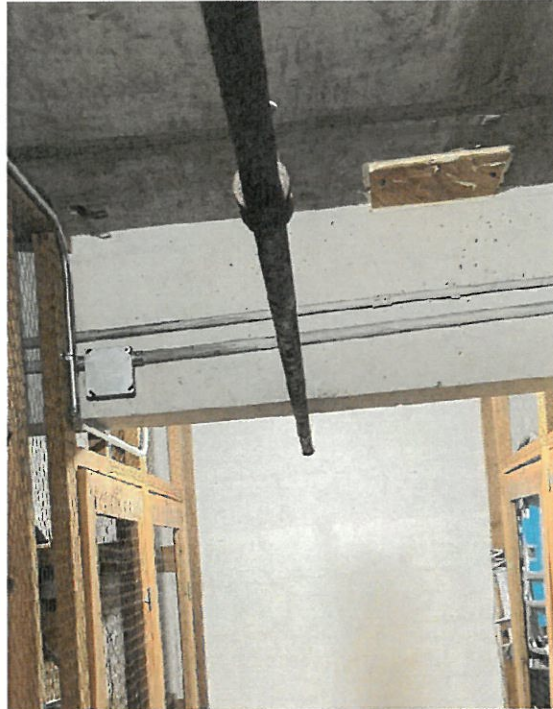
- Component Condition: Fair to Good
- Commentary: The fire suppression systems observed appeared to be in working order and showing signs of oxidation. The fire panel is reported to be reaching the end of service life with limited accessibility to replacement parts being the primary concern. The client alerted KEG that the fire pump was damaged as a result of storm surge from Hurricane Helene and has scheduled replacement with their maintenance company.
- Recommendations: Following replacement of the fire pump, regular ongoing maintenance and inspections until the control systems are scheduled to be replaced.

Fire Suppression Piping Installed in Storage Room

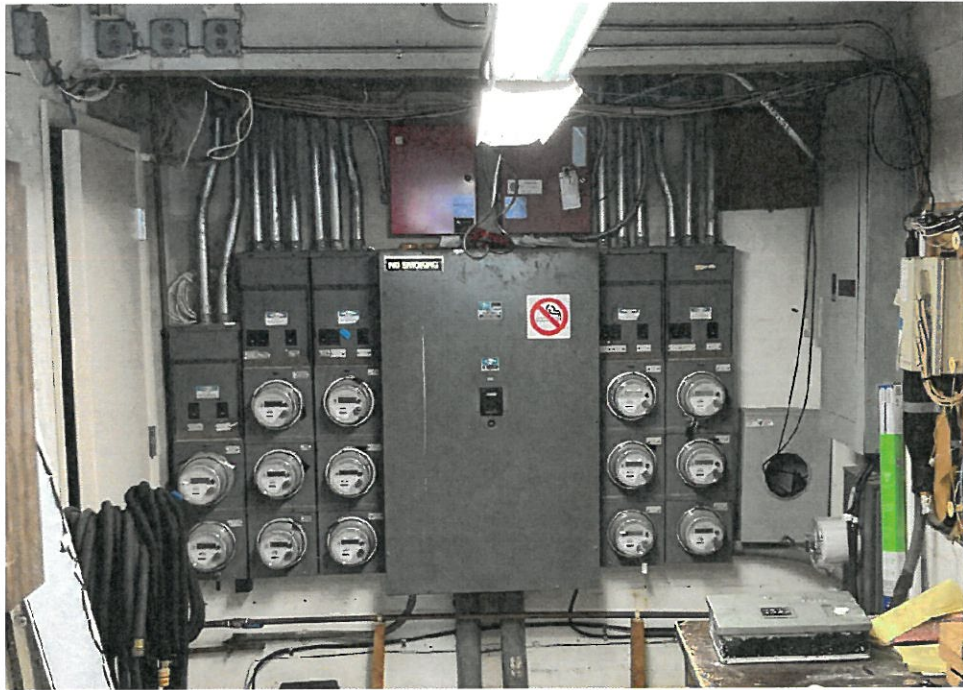
- Component Condition: Fair to Good
- Commentary: The client did not report any specific concerns with the electrical systems on the property and they visually appeared to be in fair condition.
- Recommendations: KEG recommends regular inspections by qualified professionals and replacement or repair as needed.

Electrical Systems Installed
